Manhole Inspection Summary

Manhole # S45I__037MH

Insp Date: **10/31/08 9:50 AM**

Location Address: **1800 eastern ave**

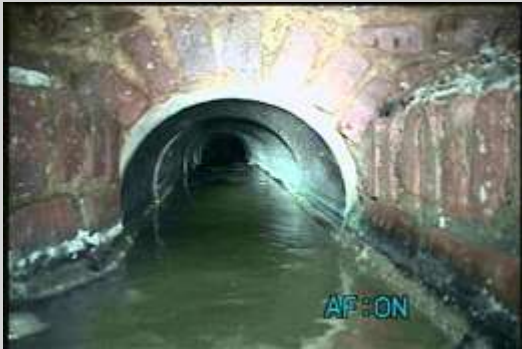
12 O'Clock Outflow

12 in. Circular Gravity Sewer
Pipe Out @ 12 O'Clock

Pipe Material: **Clay** ☐ Pipe Lined

Invert Depth: 11.54 (ft.) Flow Characteristics: **Fast**

Deposits: ☒ None ☐ Mud ☐ Sludge ☐ Debris ☐ Grease

Infiltration: **None** Pipe Seal Cond: **Unknown**

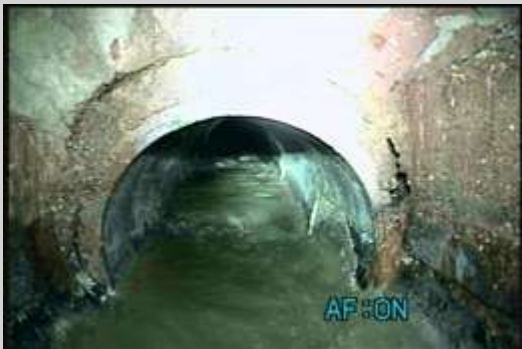
6 O'Clock Inflow

10 in. Circular Gravity Sewer
Pipe In @ 6 O'Clock

Pipe Material: **Clay** ☐ Pipe Lined

Invert Depth: 11.15 (ft.) Flow Characteristics: **Fast**

Deposits: ☒ None ☐ Mud ☐ Sludge ☐ Debris ☐ Grease

Infiltration: **None** Pipe Seal Cond: **Unknown**

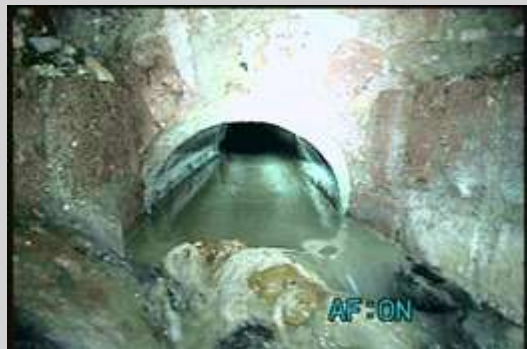
9 O'Clock Inflow

8 in. Circular Gravity Sewer
Pipe In @ 9 OClock

Pipe Material: **Clay** ☐ Pipe Lined

Infiltration: **None** Pipe Seal Cond: **Unknown**
